TECHNICAL REPORT RD-ST-88-1

ANALYSIS OF PERSHING II REENTRY VEHICLE (RV)  
CONTROL RING CASTINGS

Albert S. Ingram  
Structures Directorate  
Research, Development, and Engineering Center

MAY 1988

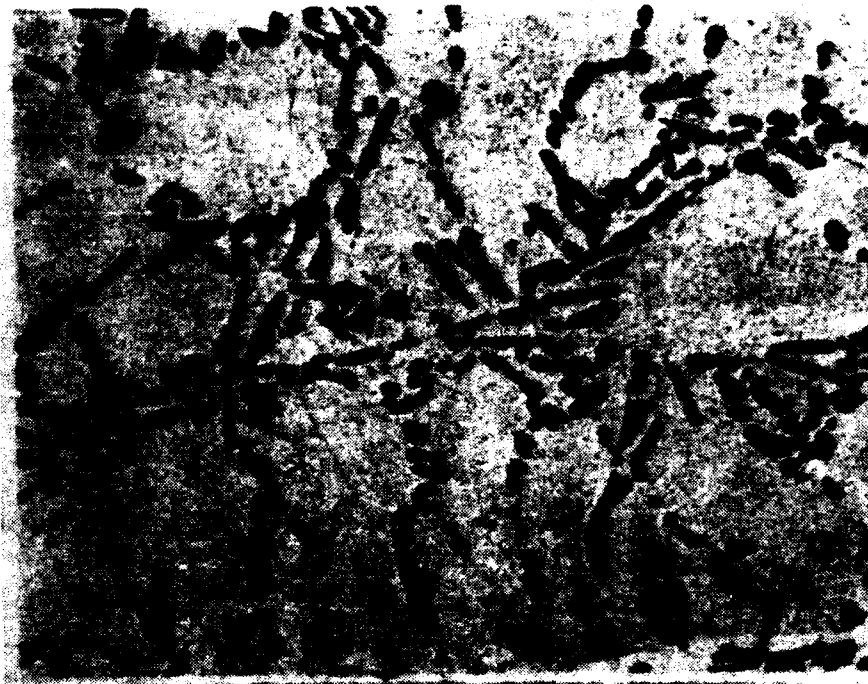
Microstructural examination was performed on the web section and jet vane port sections of both RV control rings, Figure 2. A common A356-T6 aluminum microstructure consisting of a eutectic silicon phase in an aluminum matrix was found in both RV control rings. However, the thinner web sections had finer, less angular eutectic silicon particles than did the thicker jet vane port sections as shown in Figures 7 and 8. It is believed that this is caused by different solidification rates which these sections experienced during cooling from the initial pouring of the casting. Thus, the thinner sections cool faster resulting in a finer network of eutectic silicon particles.

Figure 7. Typical microstructure found in the jet vane port section of each RV control ring. Note the size and shape of the eutectic silicon phase. Keller's ETCH (100X).

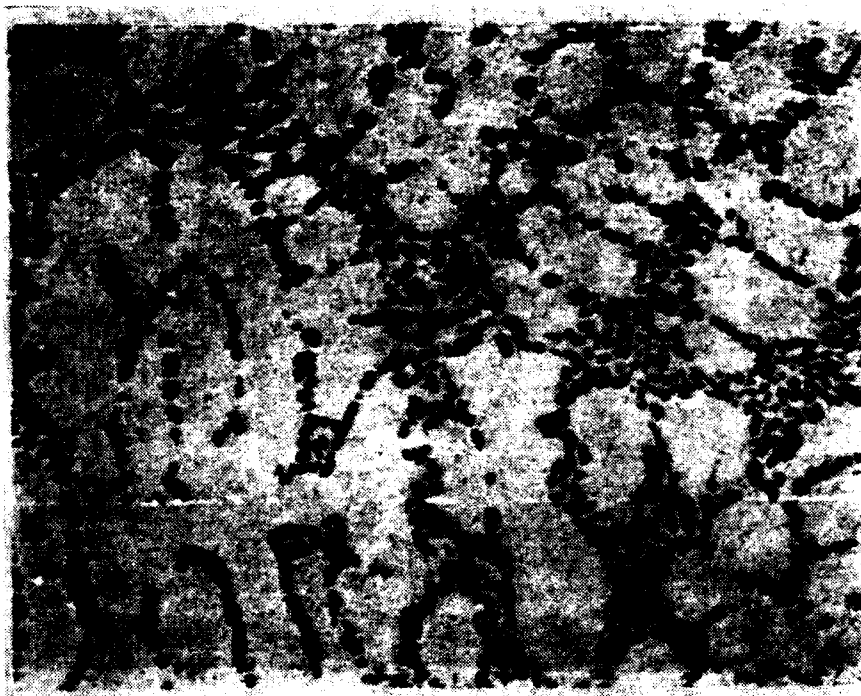
Figure 8. Typical microstructure found in the web section of each RV control ring. Compare with Figure 7 (100X).

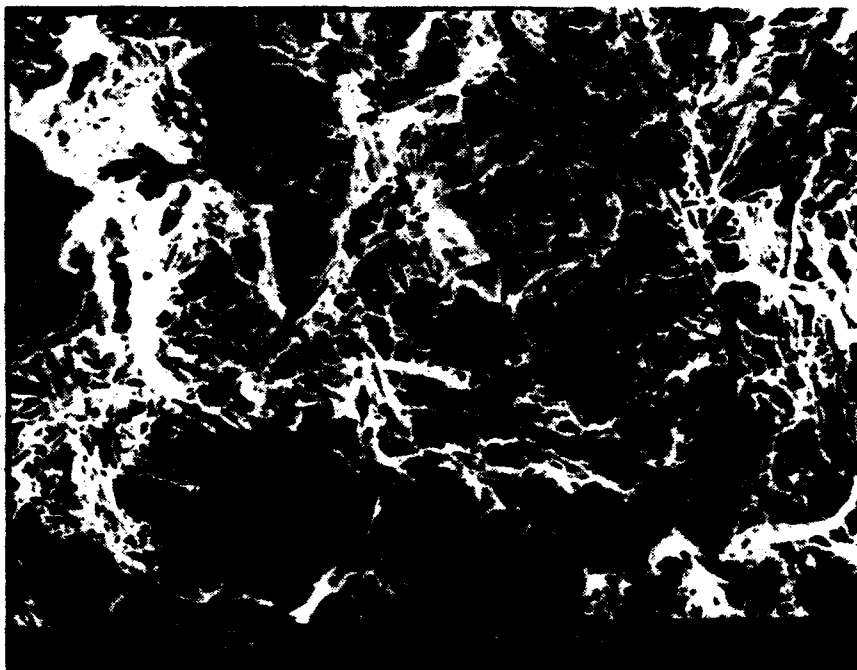
Fractographic examination of tensile samples and fracture toughness samples was performed using a scanning electron microscope. The fracture features of tensile overload and fatigue for these A356-T6 samples were very similar, Figures 9 and 10. In both tensile overload and fatigue, it is believed that crack growth aligns itself with the brittle eutectic silicon phase following the cast dendritic networks in the microstructure. This would offer fatigue crack growth and tensile overload fracture the least path of resistance, resulting in very similar fracture features. Only in a few isolated areas of the fatigue zone was there clear evidence of fatigue striations, Figure 11. Fractographic examination of samples from the two RV control rings yielded no significant differences.

Figure 10. Typical fracture morphology of tensile overload. This was found in tensile test samples and the fast fracture zone of fracture toughness specimens. Compare with Figure 9 (100X).

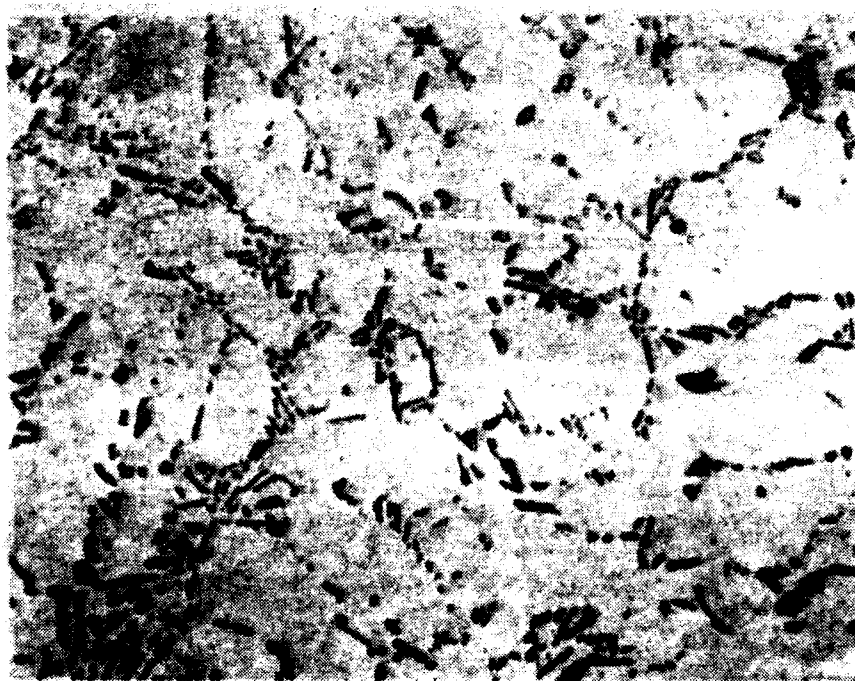
No areas of localized segregated eutectic silicon were found in any samples of Group 2. However, some samples in Group 2 did display a lesser breakup and spheroidization of eutectic silicon than would be desired for optimum mechanical properties (Figure 20). Better mechanical properties and ductility will normally be obtained if the eutectic silicon phase is broken into smaller particles, i.e., spheroidized. This is accomplished by an adequate solution heat treatment, i.e., by using the proper temperature and time. Note the degree of spheroidized eutectic silicon phase found in a 10 percent elongation sample (Figure 21). Though other factors such as chemical impurities may influence spheroidization, proper solution heat treatment is usually the most important.

Figure 20. Microstructure of Group 2 tensile coupon having 6 percent elongation. Compare to Figure 21 (100X).

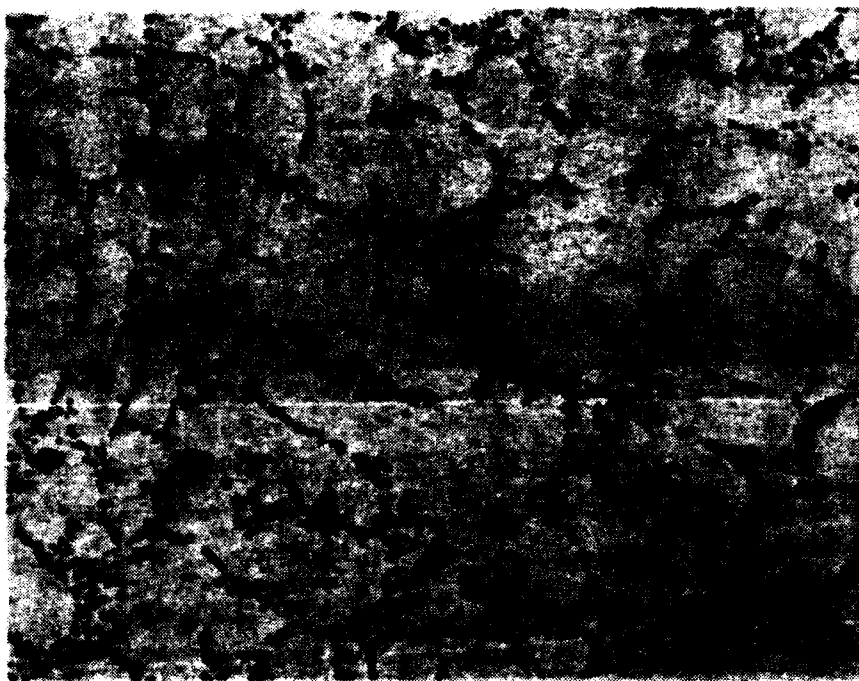
Figure 21. Microstructure of Group 2 tensile coupon with 10 percent elongation. Compare to Figure 20 (100X).
